High-Resolution Satellite Imagery Assessment of Osh, Kyrgyzstan

**Summary Report
25 June 2010**

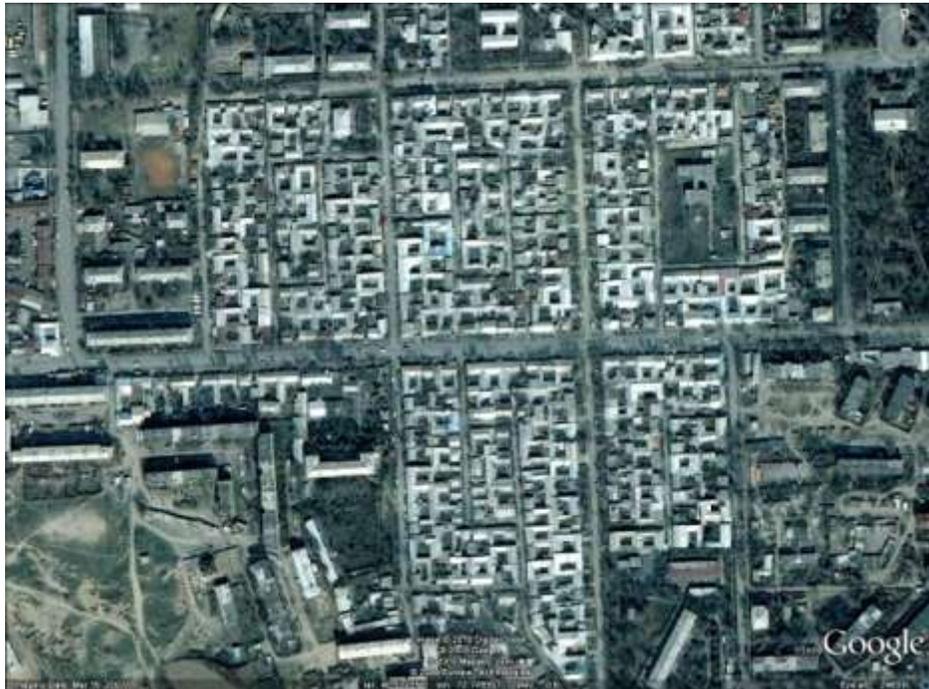
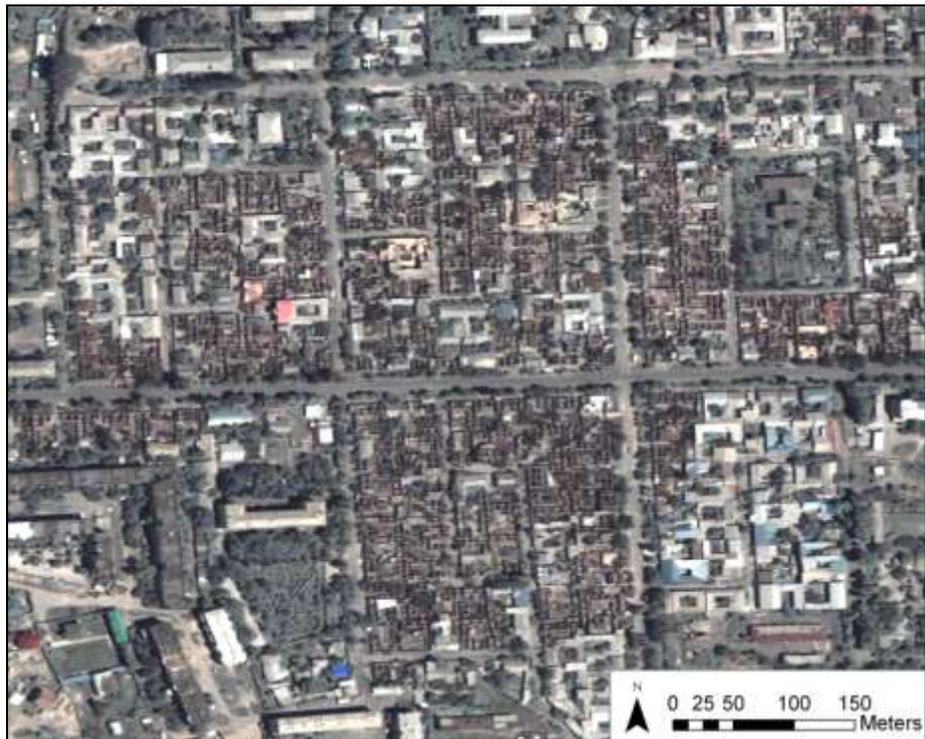
Figure 2A: 15 March 2007

While most of the city appears largely intact, where damage is present, it appears to be severe. Large swaths of buildings in the city appear to have been destroyed (Figures Two and Three). The discontinuous distribution of the destruction largely appears to follow the major east-west road in the city (Figure One), but is also found in the northern and eastern suburbs.

Entire neighborhoods appear to have been destroyed; their empty shells contrast sharply with the few undamaged buildings remaining in this area. The “before” image (top) is from 15 March 2007 and the “after” image date is 18 June 2010. The 18 June image illustrates a subset of damage to the Cheremushki neighborhood, to the west of Osh. Coordinates: 40.522525, 72.776595

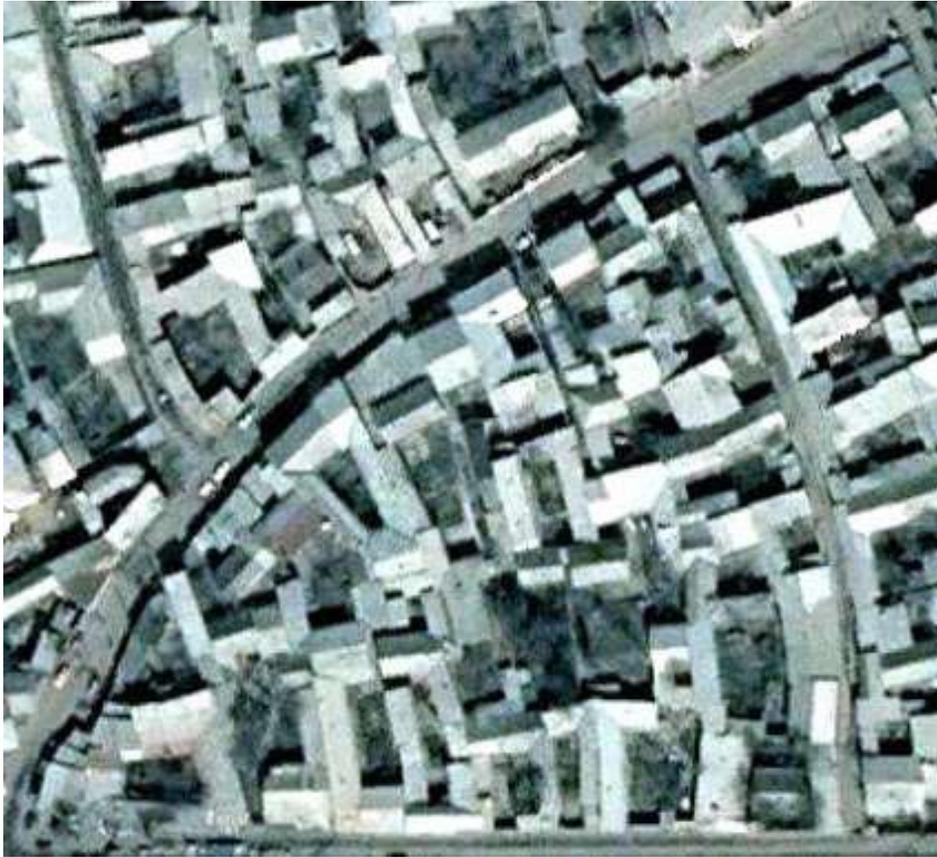
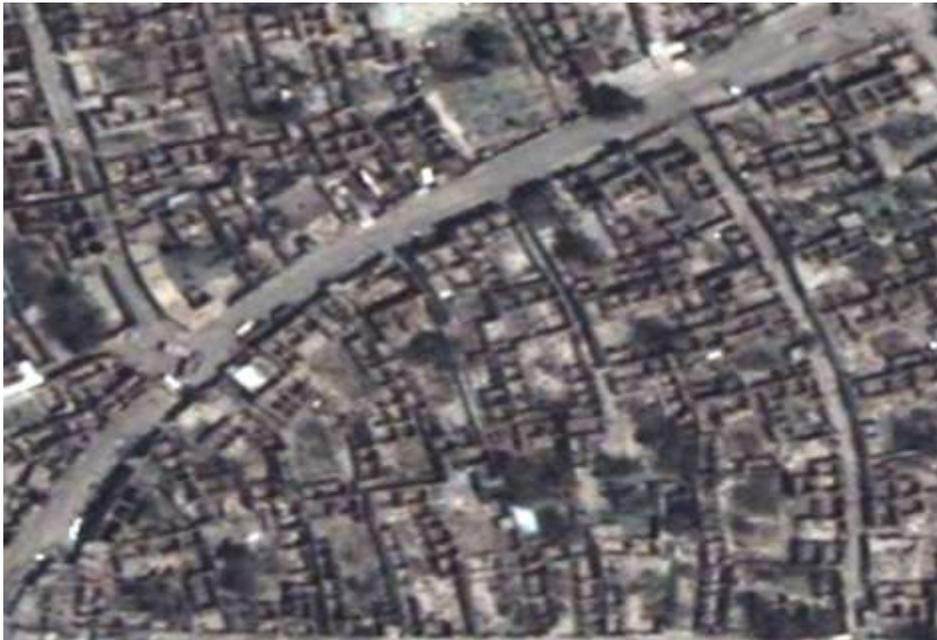
Figure 3A: 15 March 2007

Figure Three: Subset of Furkat neighborhood, located east of central Osh, which sustained heavy damage. Coordinates: 40.536, 72.813

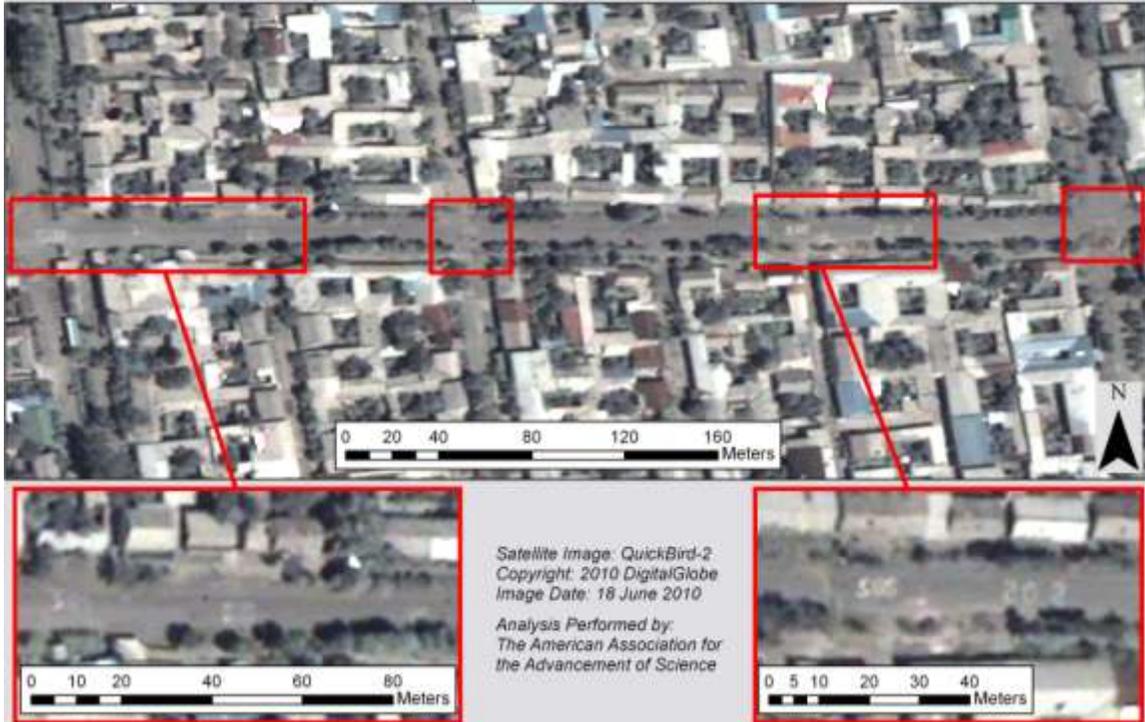
Figure Four: "SOS" Signs in Osh

In addition, on numerous occasions the letters “SOS” appear on roadways and athletic fields throughout the city (Figure Four). The sizes of these messages are at times quite large, and their shape and orientation shows little regard for the viewing angle or perspective of ground-based observers; it is likely that many of them would be difficult to read, except from above. The total count of “SOS” messages within the study area is 116 (Figure Five), the majority of which appear in intact neighborhood areas.

Several of the 116 identified "SOS" messages appear throughout the city, many painted on roads. These particular examples are painted across two lanes of roadway. Coordinates: 40.523, 72.788
