# Geospatial Technologies and Human Rights Project

Negeha, South Darfur:  
High-Resolution Satellite Imagery  
and Destruction of Housing Structures

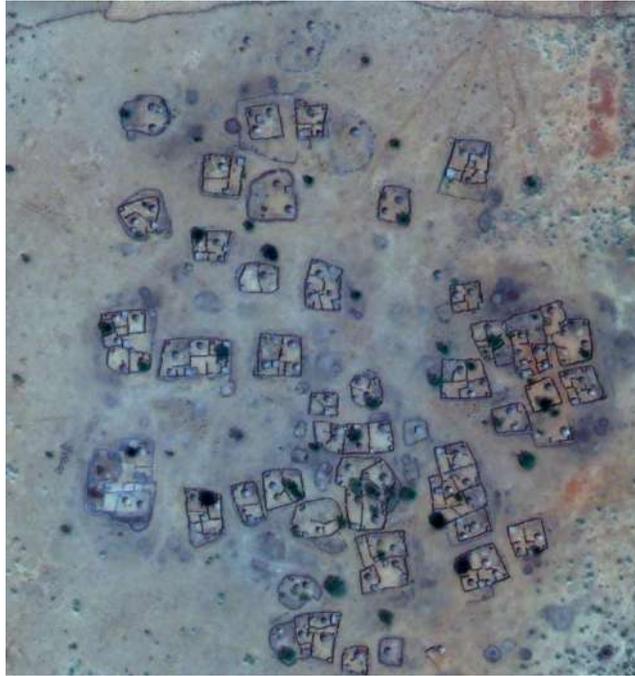
*Figure Four*

*January 13, 2010: This cluster of homes appears to be relatively intact, although outlines of former homes can be seen on the ground. (12.884 N, 25.369 E) Image © 2011 GeoEye, Inc.*

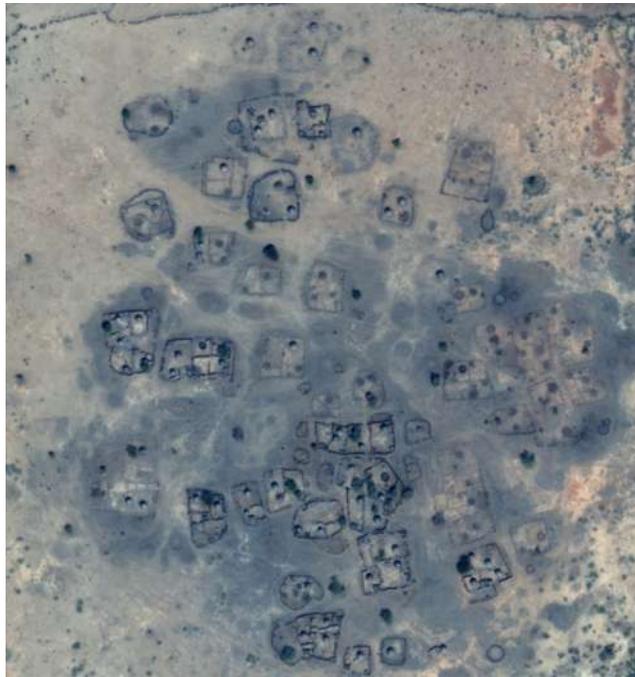
*December 24, 2010: In this more recent image, 55 of the original structures are no longer visible. The darkened appearance of the ground is likely from charring that occurred during a fire. (12.884 N, 25.369 E) Image © 2011 DigitalGlobe, Inc.*

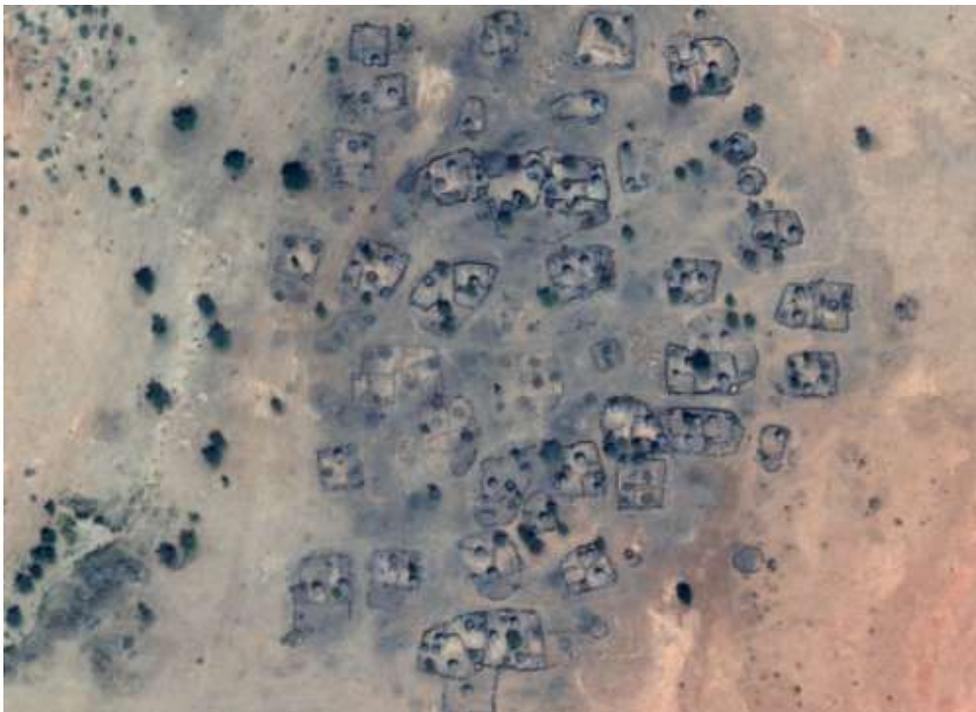
*December 24, 2010: While some of the original structures appear intact, 42 others have been completely destroyed. (12.894 N, 25.353 E) Image © 2011 DigitalGlobe, Inc.*

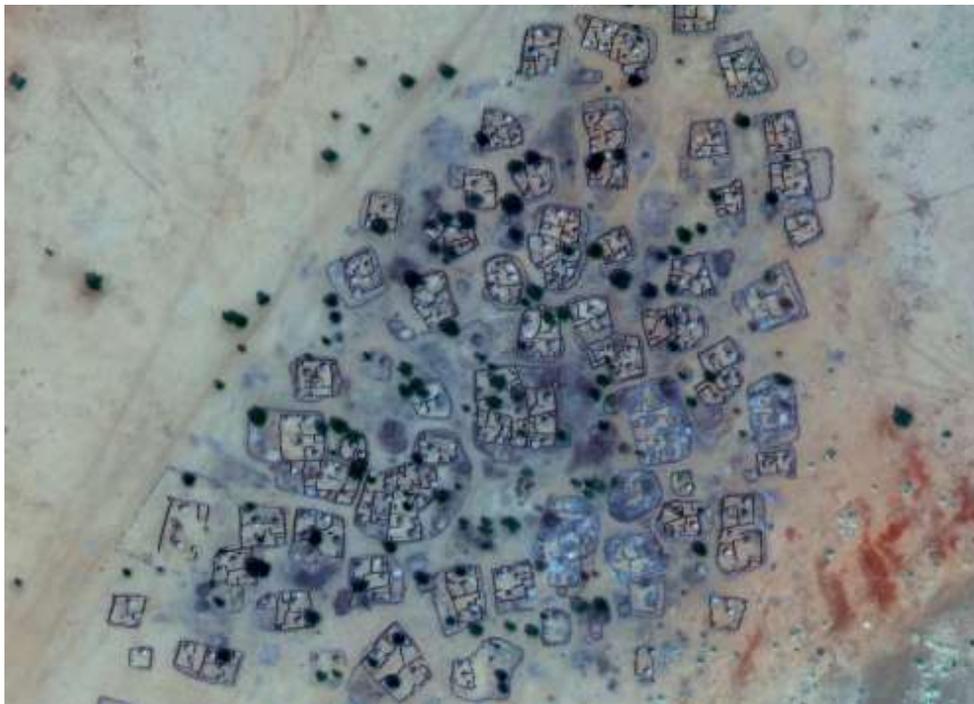
*January 13, 2010: 37 damaged buildings are apparent in the lower-right quadrant of the image. The whitish-gray color indicates ash that was likely a result of fire. (12.902 N, 25.411 E) Image © 2011 GeoEye, Inc.*

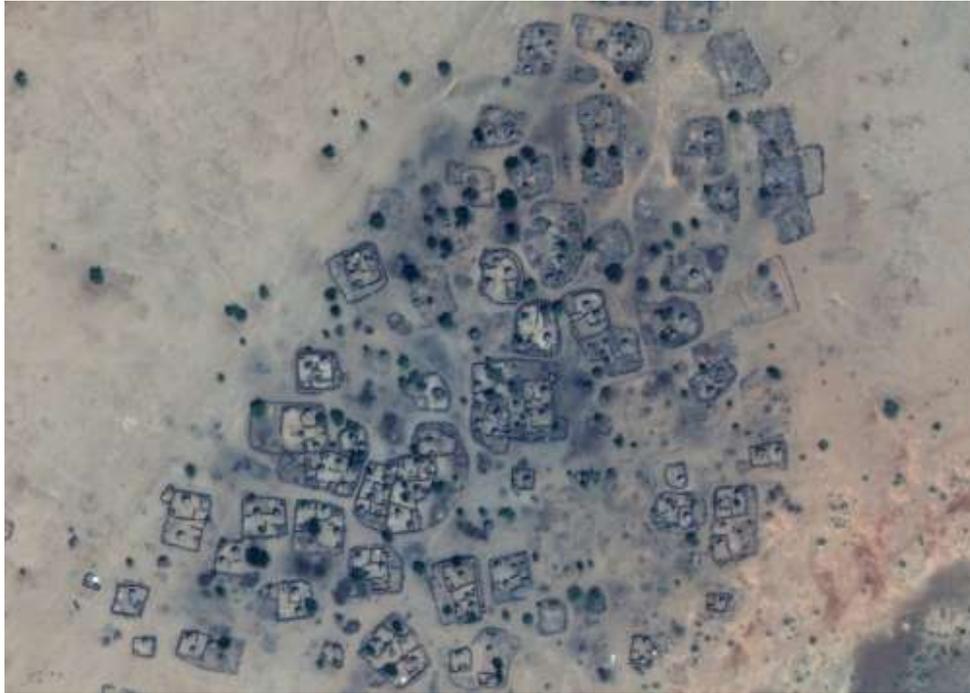
*December 24, 2010: Since January, an additional 39 dwellings in the northern portion of the image have been destroyed. (12.902 N, 25.411 E) Image © 2011 DigitalGlobe, Inc.*
