Geospatial Technologies and Human Rights Project

Documentation of Petrochemical Release:
Bodo, Nigeria

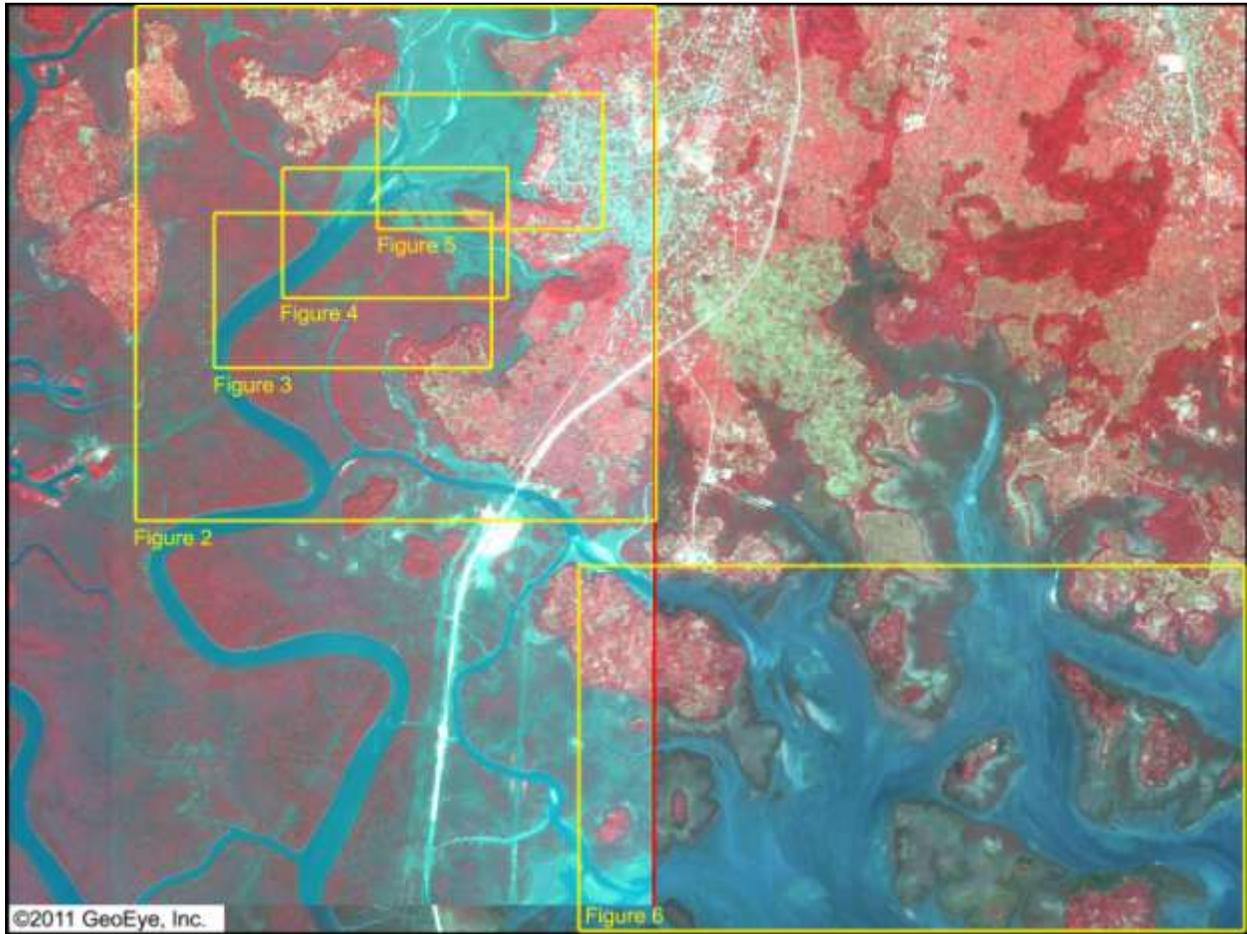
Figure 1. Overview of the affected area prior to the reported oil spill

This image of the affected area shows the town of Bodo (above, center), the intertidal zone (upper left) and adjacent waterways. In this false-color image, healthy vegetation appears bright red. The locations of figures on the following pages are highlighted in yellow. Note: differences in color between left and right sides of the image are a result of imagery which was collected on different days and times.

Imagery acquired on 4 December 2006, several years prior to the reported oil spill, was obtained by AAAS in order to serve as a baseline for subsequent observations. This imagery indicates a relatively minor ecological impact from the development of petrochemical infrastructure in the region. Pipelines and extraction facilities are visible, however most riparian vegetation appears healthy, and no pollutants are readily visible in the tidal rivers and streams that encircle Bodo.

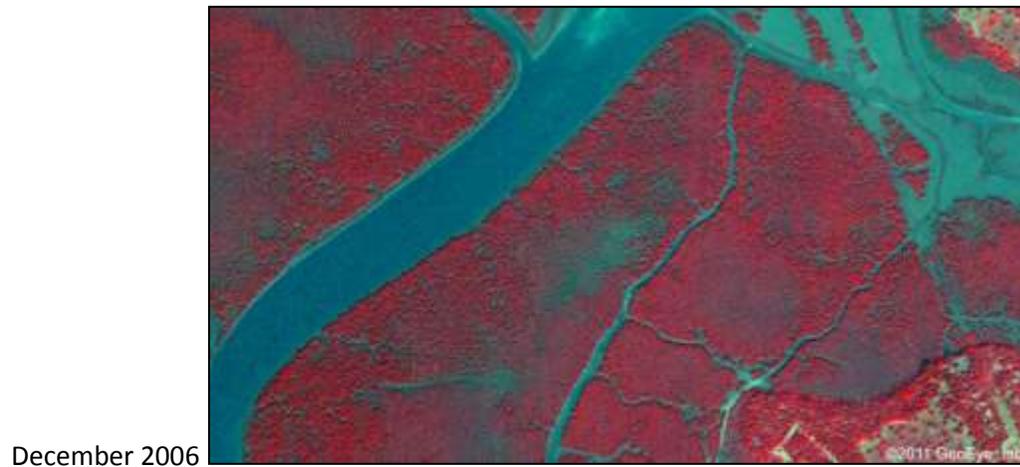
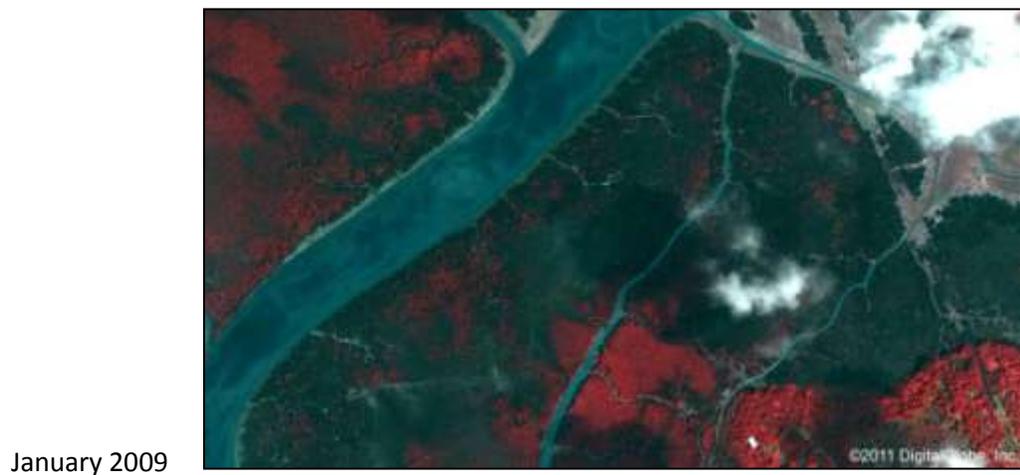
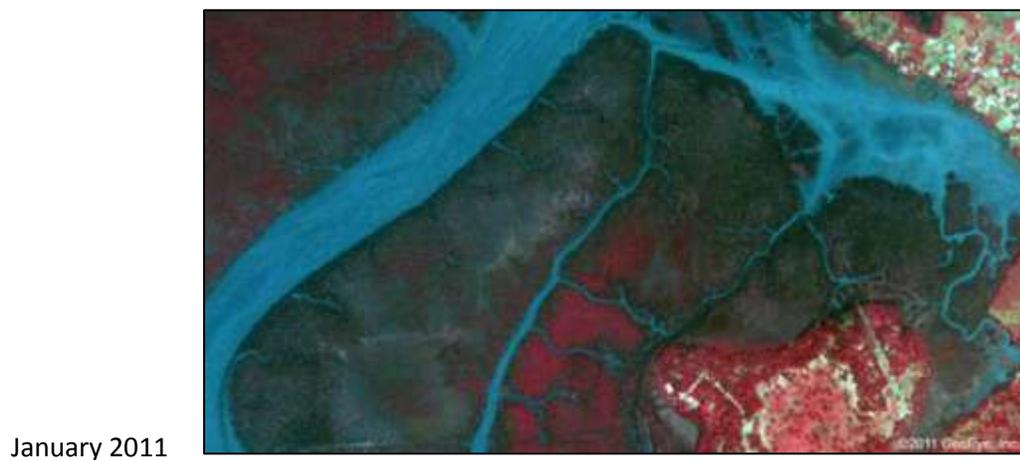
Figure 3. Close-up of vegetation death southwest of Bodo town

False-color imagery of waterways southwest of Bodo between 4 December 2006 (top) and 26 January 2009 (middle) appear consistent with reports of an oil spill, with vegetation death concentrated primarily near the river and its tributaries, while areas further inland appear less affected. Two years later, in January 2011, (bottom), little recovery is visible.

Imagery was also obtained to examine any changes to the area since 2009. AAAS acquired an image of the Bodo area dated 8 January 2011 (Figure 6), which clearly shows the continued presence of petrochemicals in the area. A timeline of the oil spill can be seen in Figure 3, which focuses on one area near Bodo. Considerable degradation is apparent between the image taken prior to the oil spill and that taken soon after the spill. Between the recent post-spill imagery and another taken nearly two years after the spill, however, little improvement is visible.

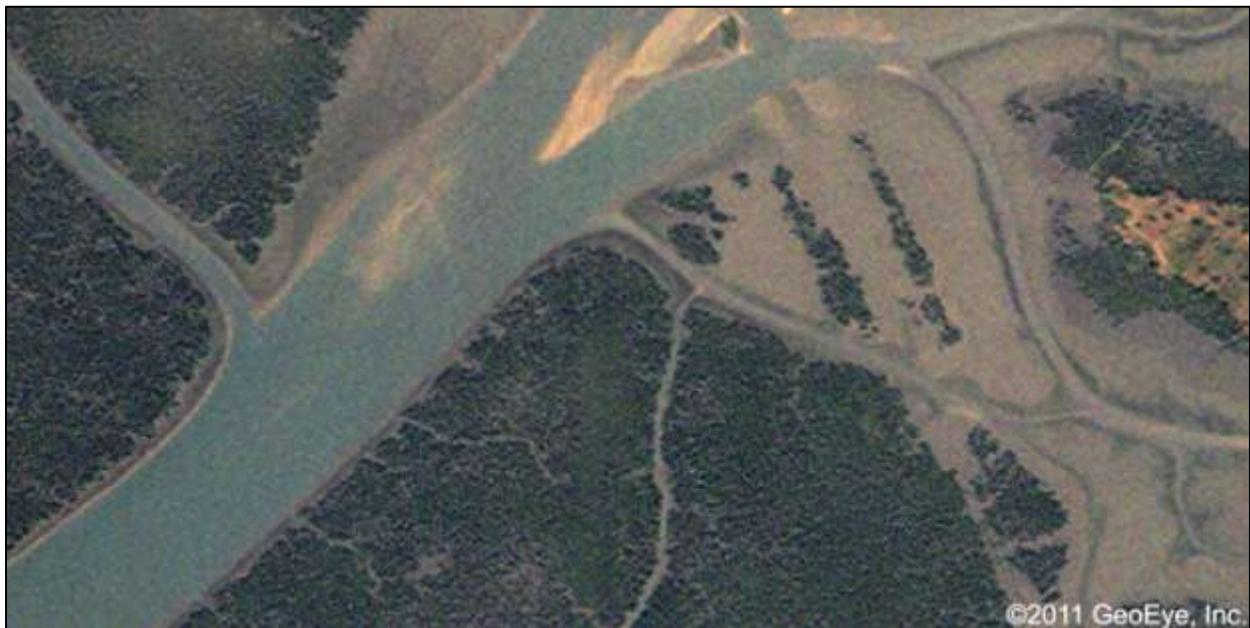
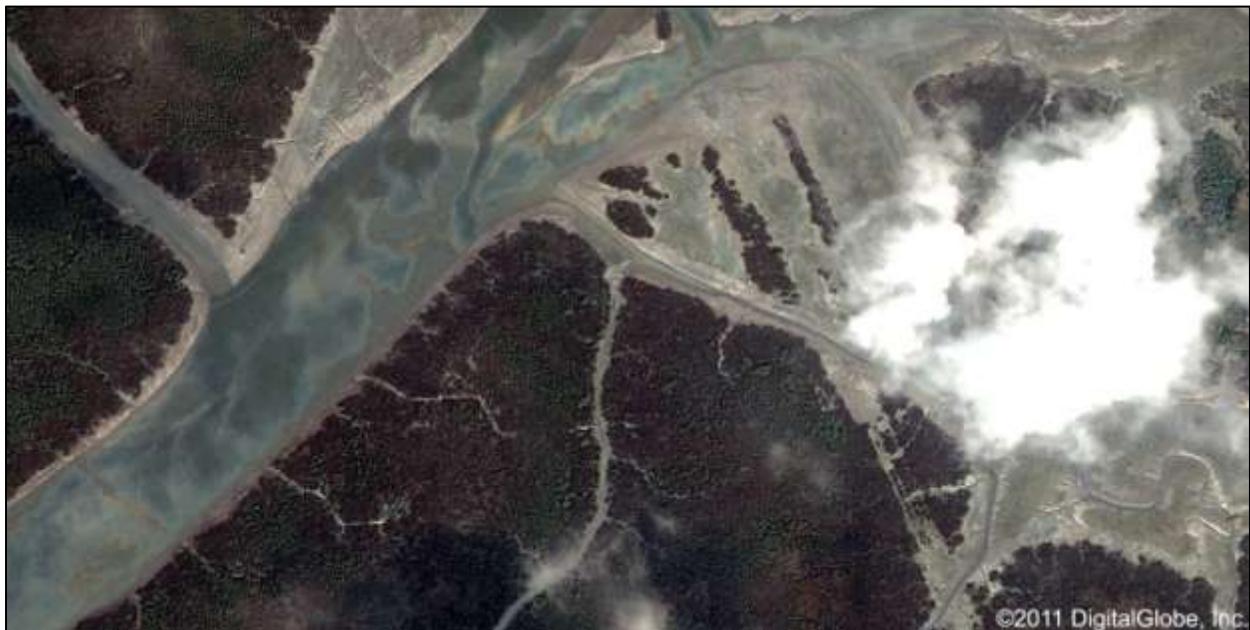
Figure 4. Effects of a reported petrochemical spill near Bodo, Nigeria

True-color satellite imagery of waterways southwest of Bodo also reveal signs of petrochemicals. Between 4 December 2006 (top) and 26 January 2009 (bottom), the river has developed the rainbow sheen characteristic of an oil slick and adjacent tidal flats have changed color from a sandy yellow to an oily grey.

By 26 January 2009, the date of the second image obtained by AAAS (Figure 2), the situation had changed. Large swaths of vegetation – especially in proximity to waterways – appear dead. A rainbow effect is visible in the main waterway leading to Bodo (Figure 4), and the tidal flats adjacent to the settlement (on which the boats of local residents are visible) have changed from a muddy yellow to an oily grey color (Figure 5). In order to quantify the extent of the damage, AAAS performed a supervised multispectral classification on the January 2009 image, which indicated that approximately three square kilometers of vegetation had been destroyed – a result which agrees with estimates derived through visual interpretation and quantification.

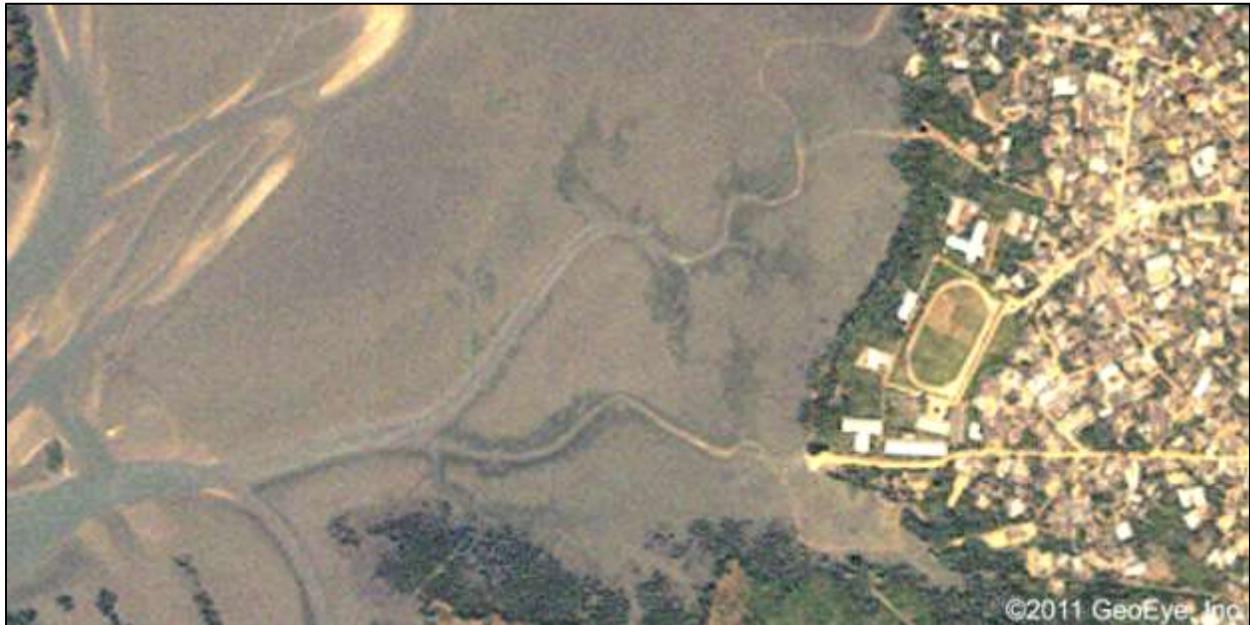
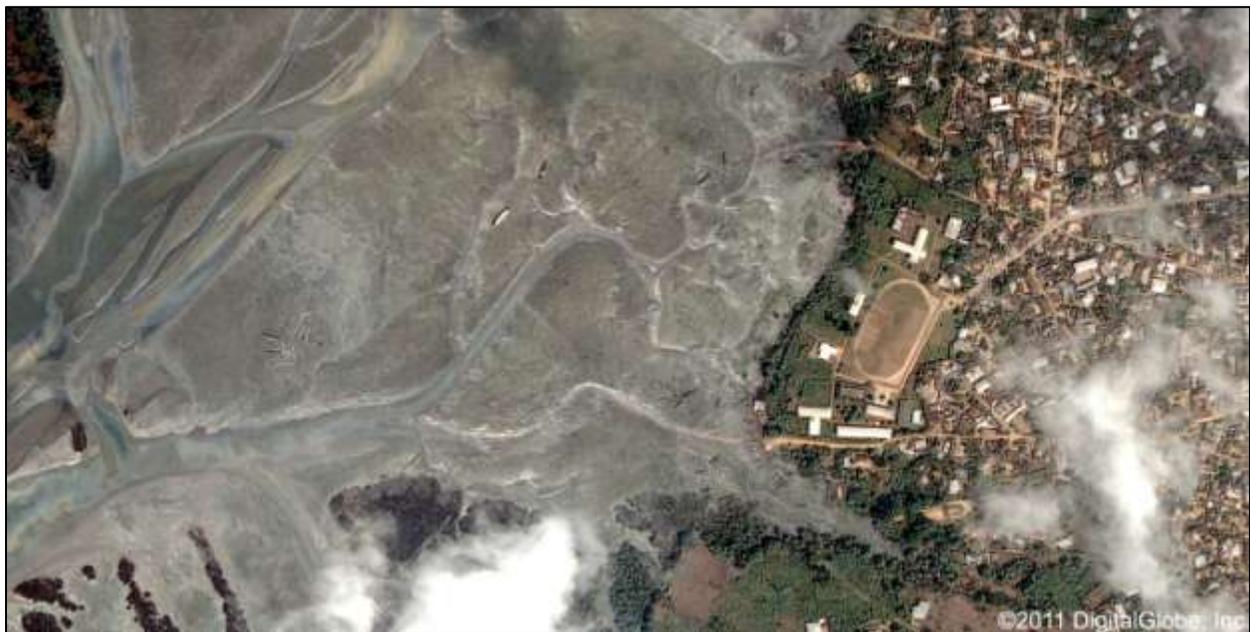
Figure 5. Focus on the river near Bodo Town

The streams and tidal flats directly adjacent to the town of Bodo appear similarly affected by the reported oil spill. The rainbow slick visible in the channels and discoloration of the intertidal zone on 26 January 2009 (bottom) is consistent with ground-based information obtained by Amnesty International and contrasts the 04 December 2006 image (top) which is unaltered by oil.

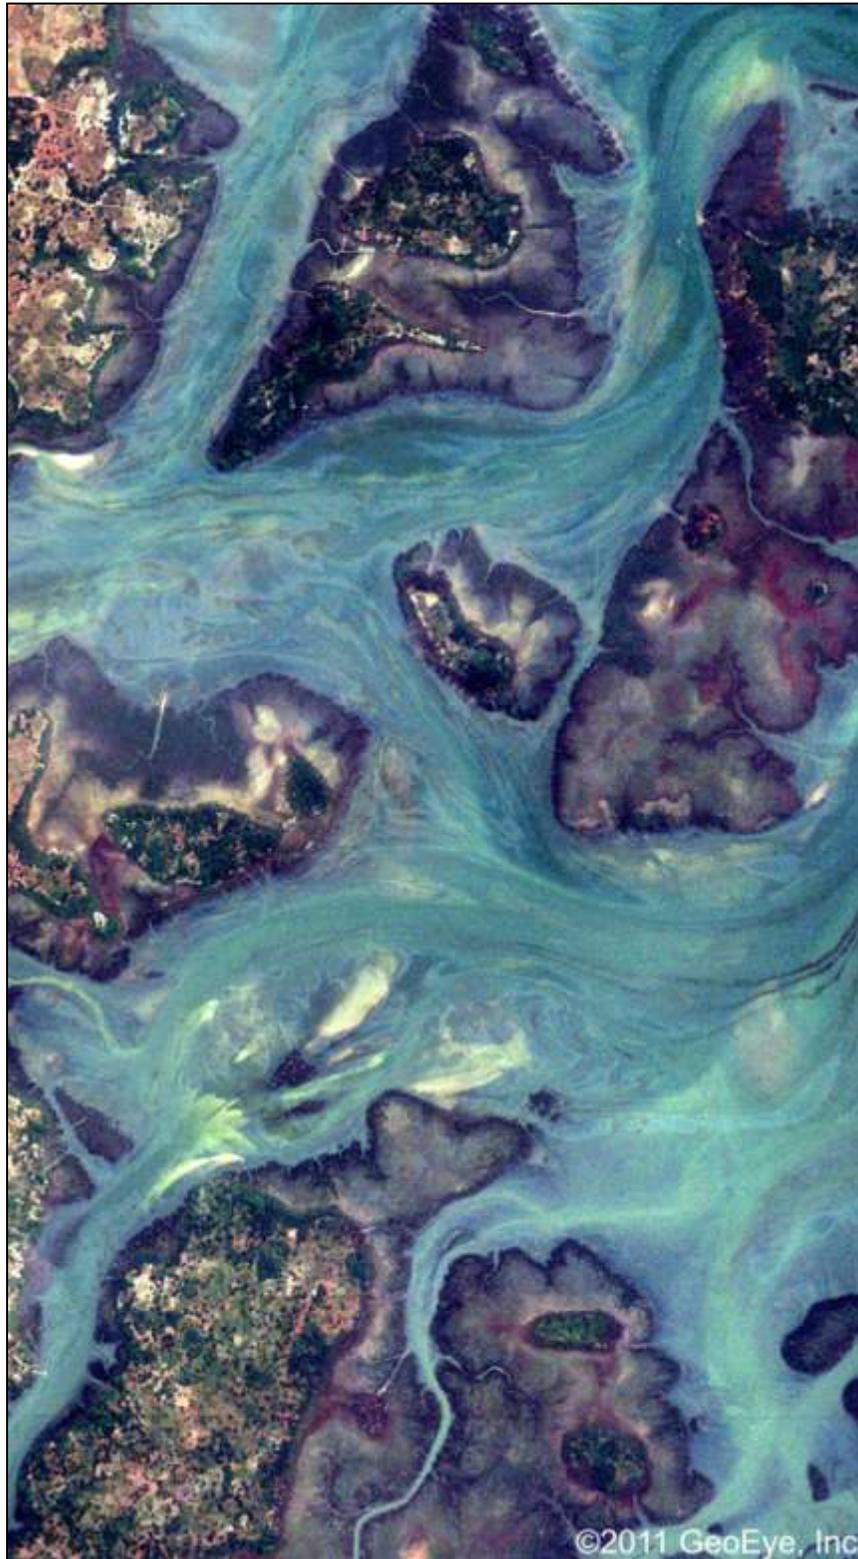
Figure 6. Lingering effects of the spill

On 8 January 2011, over two years after the reported spill, an oil slick stretching for more than five kilometers remains visible in the waterways southeast of Bodo town. North is to the left.
