Geospatial Technologies Project

Assessing the status of medical facilities in Syria
Al-Quds Hospital

April 2016

Al-Quds Hospital Bombing

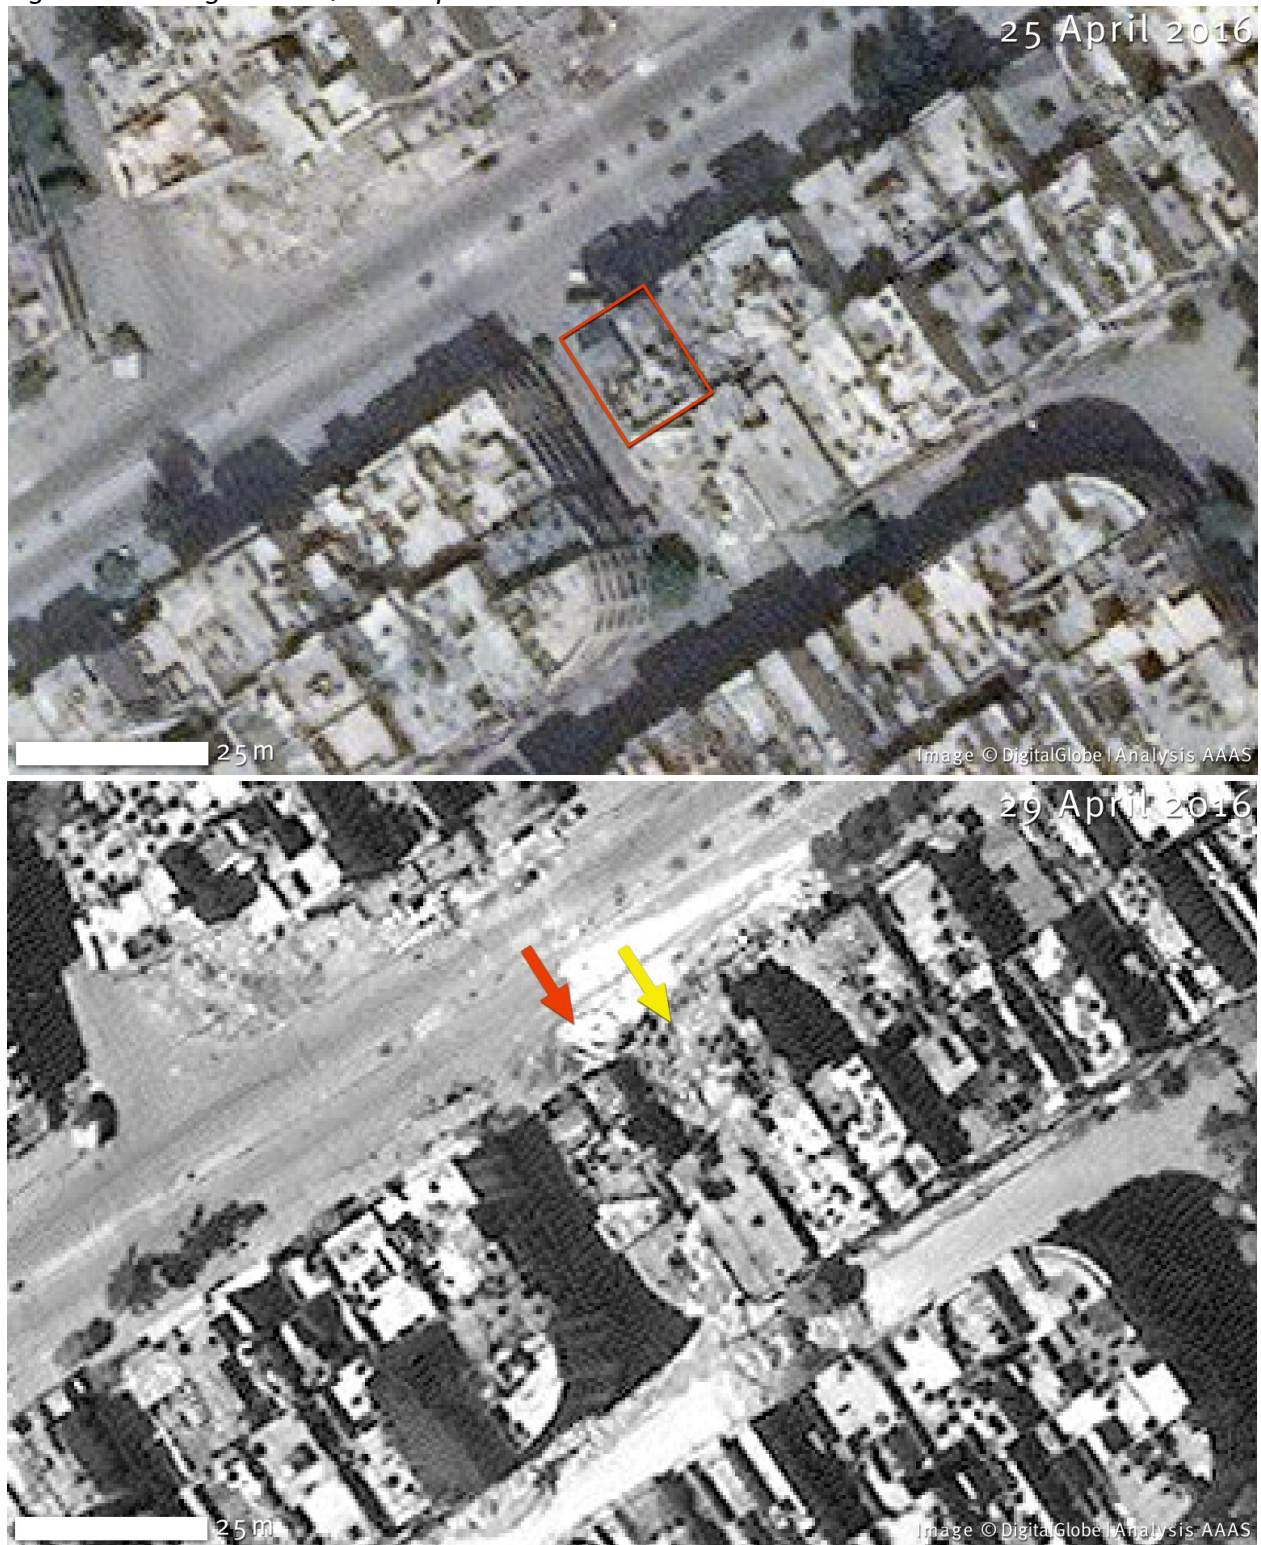
Figure 1: Damage to Al-Quds Hospital

Analysis of satellite imagery reveals that a large debris apron appeared in the street in front of Al-Quds Hospital between 25 April 2016 and 29 April 2016. Debris aprons often indicate the presence of damage to the façade of a building that cannot be directly observed via satellite imagery. In addition, the building immediately adjacent to the hospital completely collapsed during the same time period. These findings are consistent with reports of the hospital being struck by large ordnance.

On 25 April 2016 (top) Al-Quds Hospital (red box) appears undamaged. By 29 April 2016 (bottom), a debris apron is present in the street in front of the hospital (red arrow) and the building immediately adjacent had collapsed. Image ©DigitalGlobe | U.S. Department of State, NextView License | Analysis AAAS.
